# Rust belts

Are plastic sleeves causing propane cylinders to rust? The industry finds itself in an intense debate on whether it's all overreaction or a serious issue.

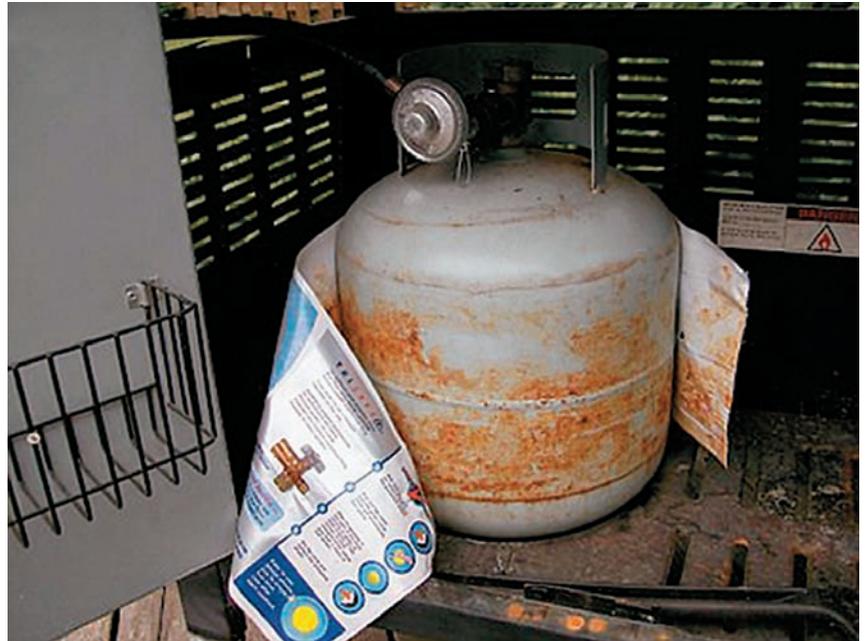
**Dozens of people in the industry say rust forms behind the plastic bands.**

Dozens of cylinder refillers, exchangers, refurbishers and safety officials from across the country say there is an issue with rust forming behind the plastic bands. They suspect it is caused by moisture – from outdoor storage and the condensation that forms during tank use – getting trapped between the non-permeable plastic band and the steel tank.

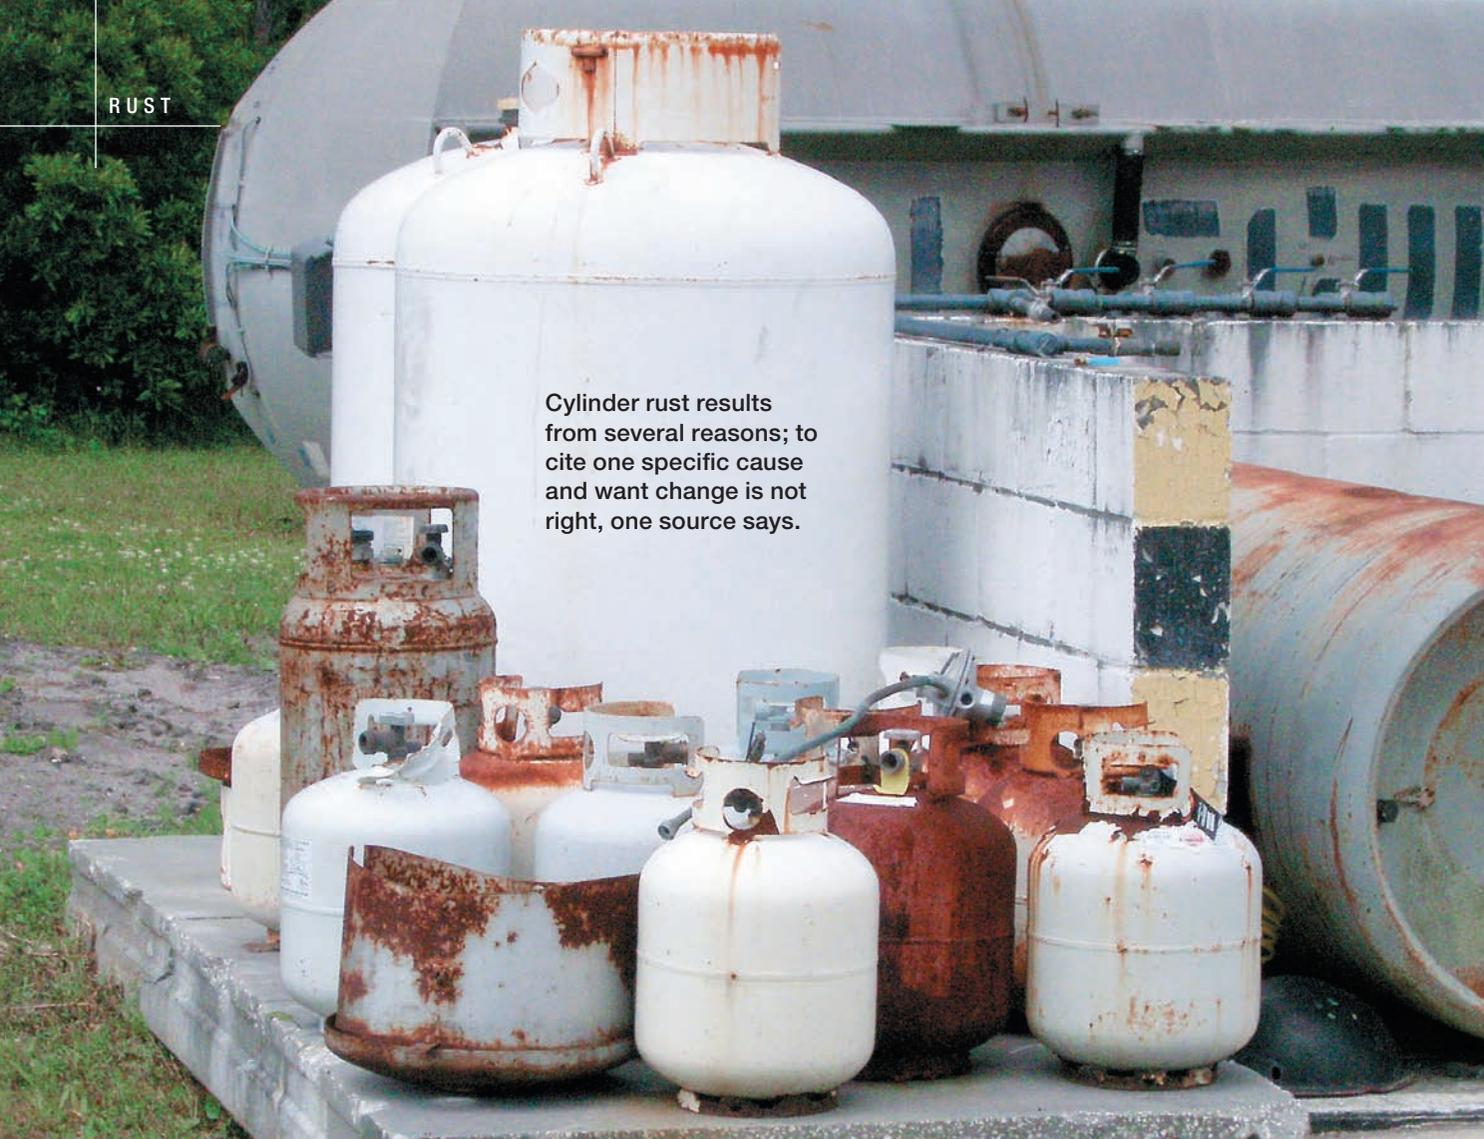
Cylinder rust results from several reasons; to cite one specific cause and want change is not right, one source says.

"Cylinders that are rusting are an issue regardless of whether it's grill cylinders with a sleeve or not. To say that something is causing rust and therefore should be changed is not right. There is a myriad of reasons why rust forms on
